PRODUCT SAFETY DIRECTIVE

***Special Prevention Inspection***

**Mandatory for All Barry Long Line Jacket Owners and Users**

December 8, 2010

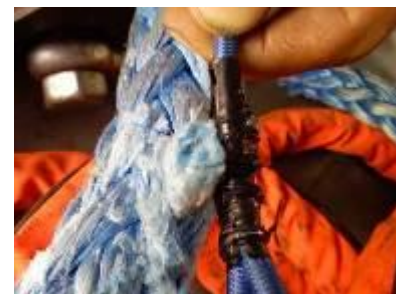
**Elastic cord:**

- The loops of the elastic cord are either formed by using a metal crimp which is covered by an electric tape, or by the use of a knot.
- A user has reported damage to a Long Line caused by the friction and abrasion of the metal crimps against the Long Line fibers.

- **Barry recommends the immediate removal of the Elastic Cord and/or Accessory Cord from both ends of the Long Lines.**

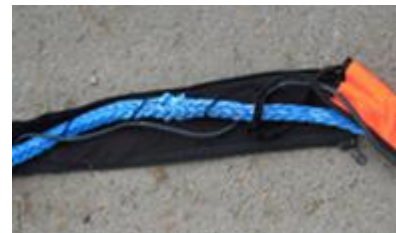
**Accessory cord:**

- The excess cord should be loosely folded inside the end cover.
- A user has reported damage to the Long Line fibers due to the incorrect placement of the accessory cord which had been tightly wrapped around the Long Line by field personnel after performing an electrical cord replacement.
