PRODUCT SAFETY DIRECTIVE

***Special Prevention Inspection***

**Mandatory for All Barry Long Line Jacket Owners and Users**

December 8, 2010

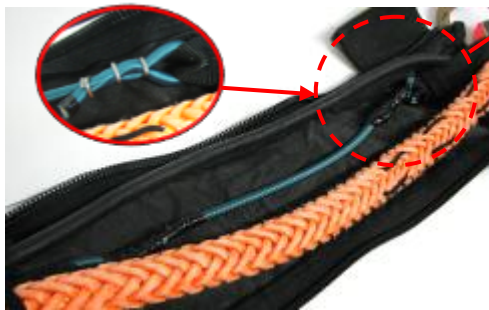
Picture of the elastic cord

- The loops of the elastic cord are either formed by using a metal crimp which is covered by an electric tape, or by the use of a knot.
- A user has reported damage to a Long Line caused by the friction and abrasion of the metal crimps against the Long Line fibers.

- **Barry recommends the immediate removal of the Elastic Cord and/or Accessory Cord from both ends of the Long Lines.**

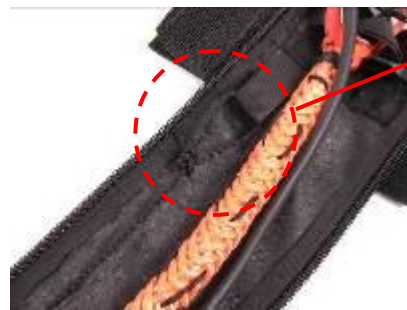
Picture of the accessory cord

- The excess cord should be loosely folded inside the end cover.
- A user has reported damage to the Long Line fibers due to the incorrect placement of the accessory cord which had been tightly wrapped around the Long Line by field personnel after performing an electrical cord replacement.
